**BEAR Scotland – NE Unit
A9 Mound Sluices M & E Refurbishment
Feasibility Study**

**Prepared by Babtie Group on behalf of BEAR
for the Scottish Executive**

BST202802/QW1/201078/Doc1

20 August 2002

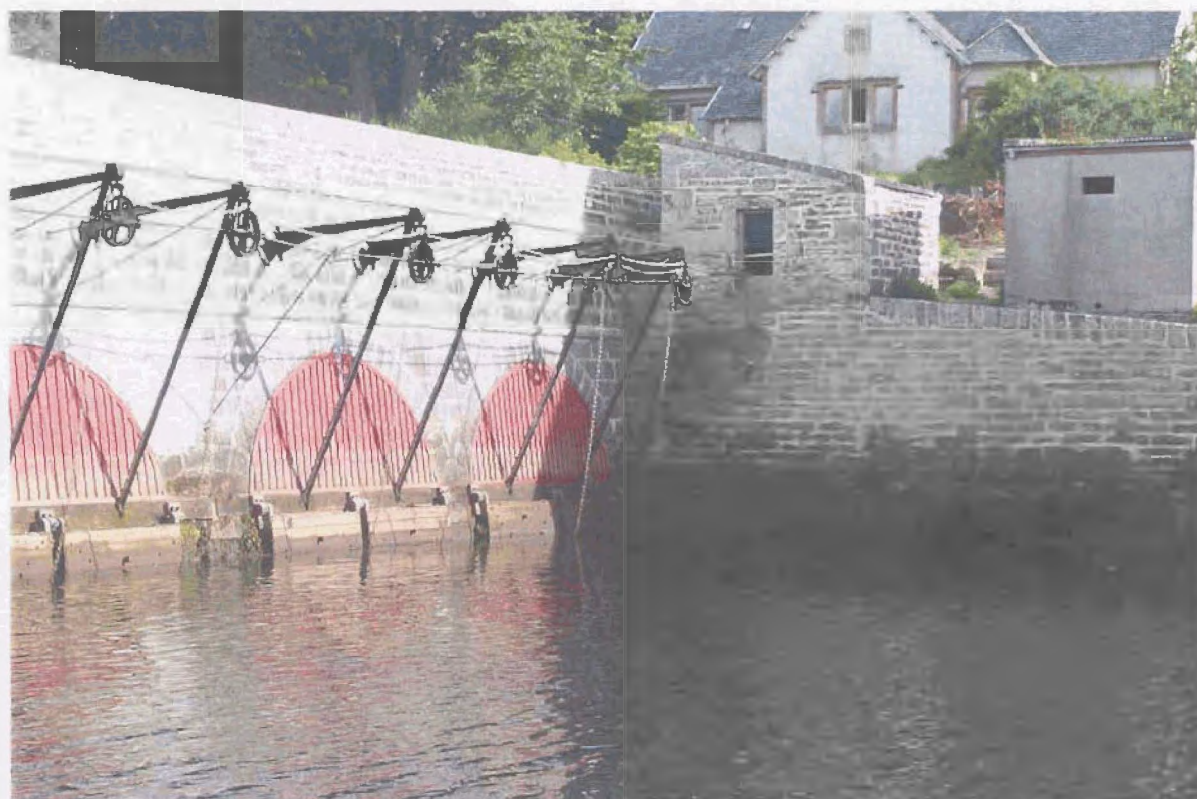
Image 1.

1. Introduction
 - 1.1 The bridge spans the River Fleet and has six arches each with a pair of sluice gates (image 1 three arches looking north towards the North winch house). The winches used for the opening of the sluice gates are extremely old and worn. Their condition has resulted in safety implications in their operation and an operator has already been injured.
 - 1.2 The object of this report is to assess the feasibility for the refurbishment of the winches enabling compliance with modern standards and with minimal impingement of the historic nature of the structure. The report will study a number of proposed solutions and then draw conclusions from the proposals based on cost and practicality.

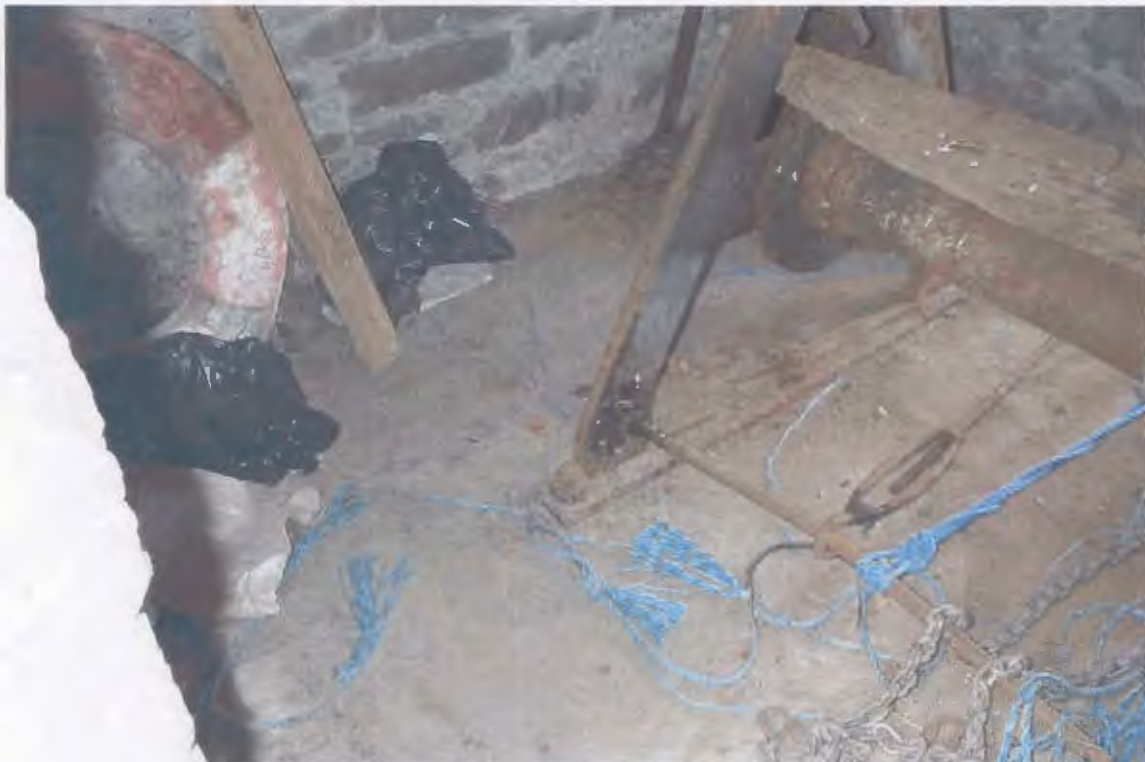
Image 2.

3.2 The winch drums are worn from their long service also the ratchet mechanism and gear teeth have suffered similarly (Image 2 South Winch, Image 3 North winch). The ratchet has worn to such an extent that it now poses a serious safety issue as it has been reported to have failed and slid on a number of occasions. In the North winch house the ratchet has completely failed and is replaced by a wooden post jammed through the spokes of the wheel.

7.5 Notwithstanding the final option selection, it is recommended that the replacement is programmed at the earliest opportunity given the life-expired condition of the existing system.

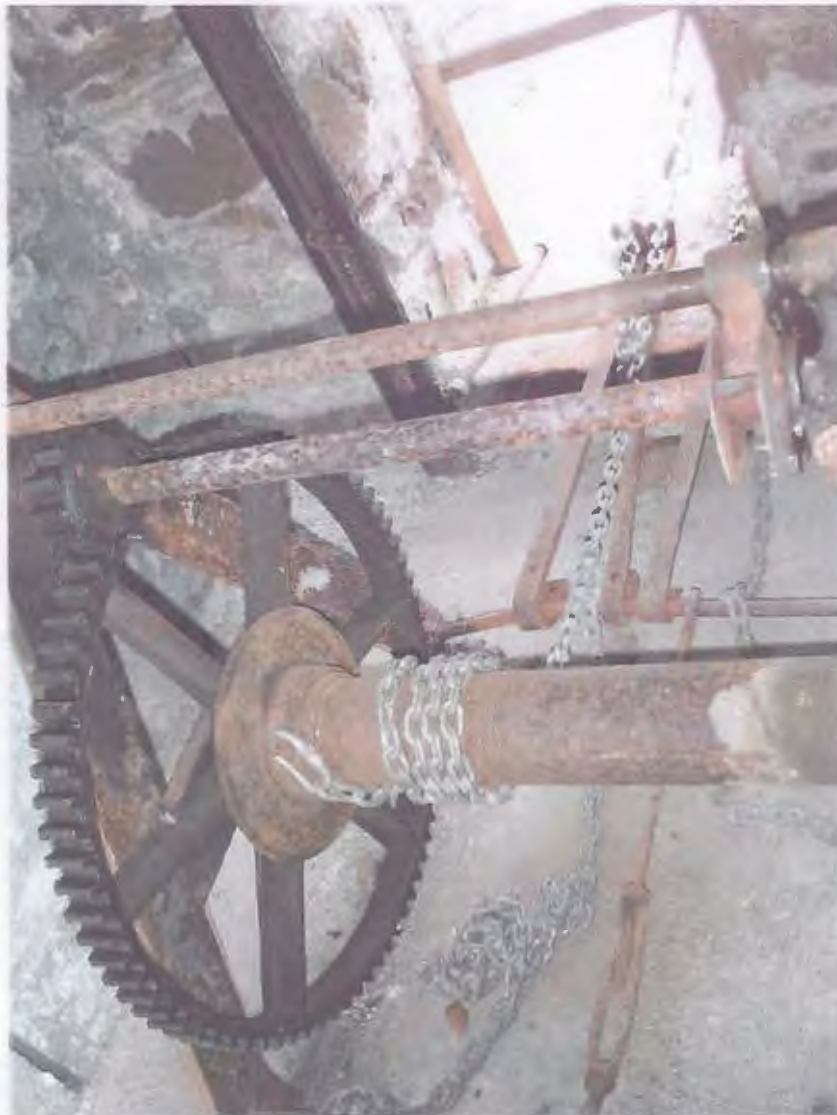
Image 3.

- 3.3 The arrangement for locking the chain off once the sluice gate is opened is in desperate need of refurbishment. In the South winch house, the cleats that the chains get jammed on are worn. The bar that the cleats latch on to has yielded and plastically deformed (can be seen in image 3). In the North winch house the latching mechanism appears to have sheared off and a dangerous make shift mechanism for holding the cleats been put in place.

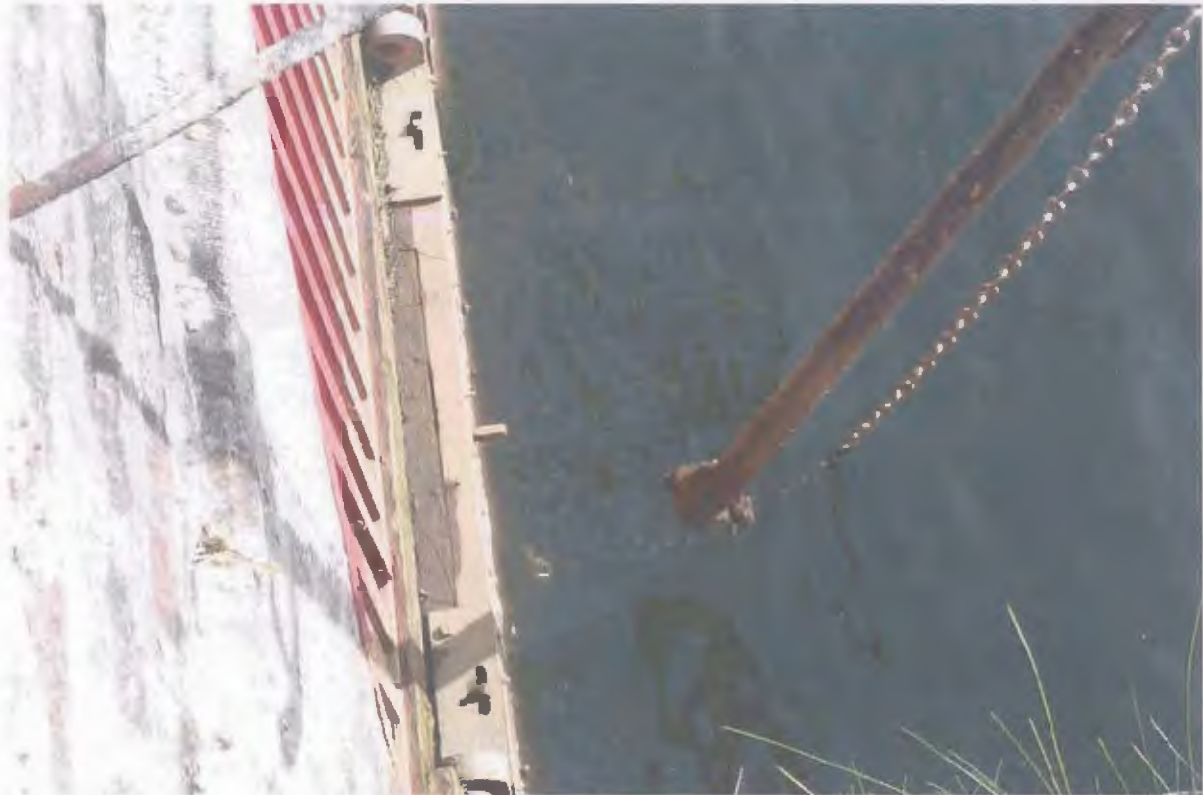
Image 4.

- 3.5 Whilst not within this scope of work it is recommended that the existing chain holding structure be surveyed to assess its fitness for purpose. It was further noted during survey that the support furthest South was not attached to the bridge structure above the gate and was hanging free (Image 4).
- 3.6 During the site visit, it was noted that above the wheels on the North side a guide on each support keeps the chains away from the pulleys. This would be considered advantageous if also introduced onto the South side to prevent the chains fouling each other during operation, thus allowing improved operation from a safety perspective.
