A RECONSTRUCTION OF THE PROBABLE ARCHITECTURE OF THE SUTHERLAND CORN-DRYING KILN — AFTER FENTON.

W. N. FENSLER

[DORNOCH HERITAGE SOCIETY.]

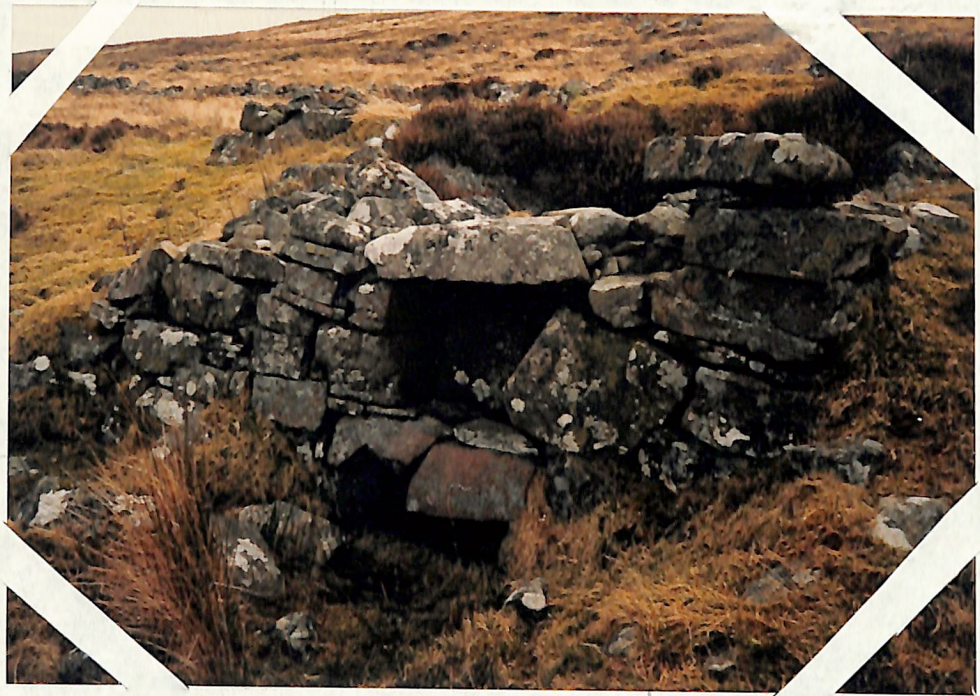
[Ref: 88/3/17-17A.]  
The slab-fronted facade of the kiln showing the fracturing of the lintel to the single, mid-line flue or stoke-hole, and slight subsidence of the right-hand side. The recess above the flue-lintel could have been used as a warming-oven, if artefact, or stones might have been removed to take weight off it and prevent further displacement.

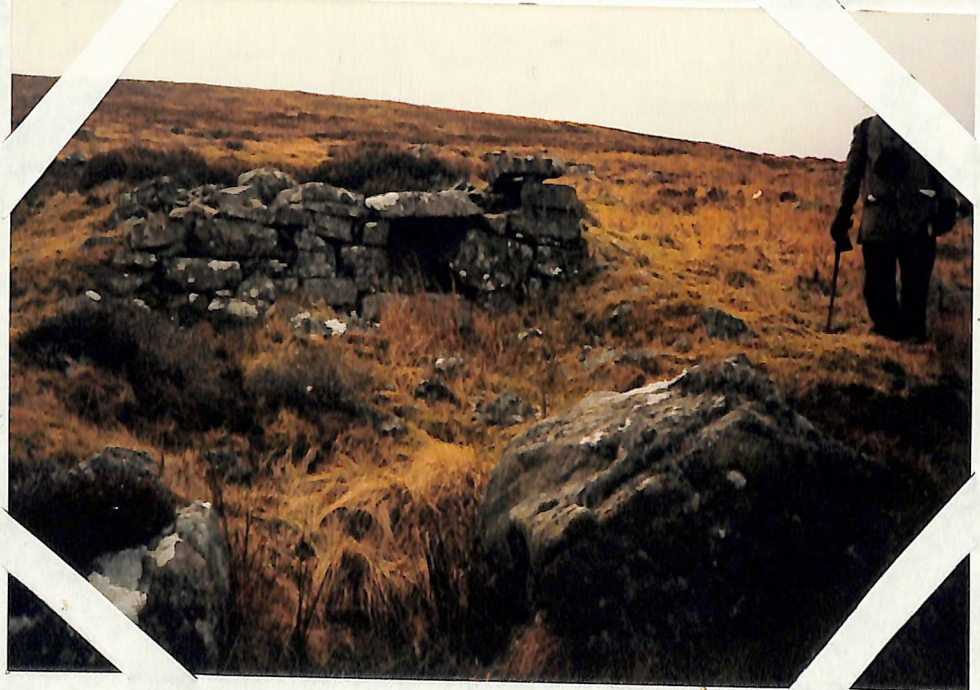
[Ref: 88/3/18-18A.]  
View from the entrance looking towards the kiln facade, illustrating the largely amorphous nature of the residual stoneworks. The great boulders defining the entrance are in the foreground.

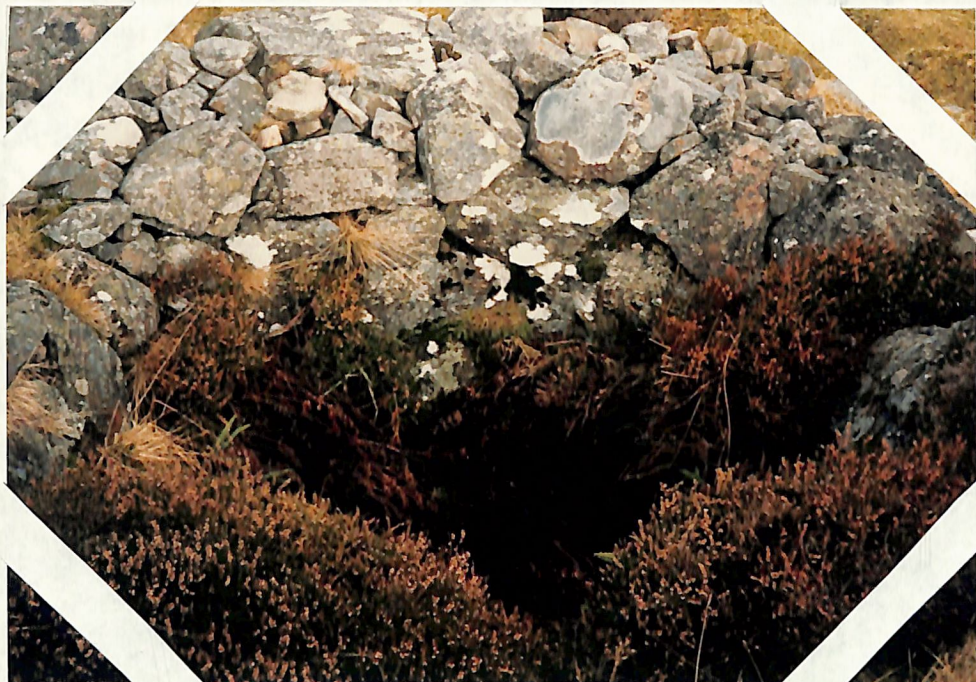
[Ref: 88/3/15-15A.]

View from the top looking northwards down into the bowl of the Kiln. The destruction of the rim is evident, despite being largely overgrown by heather and brocken.

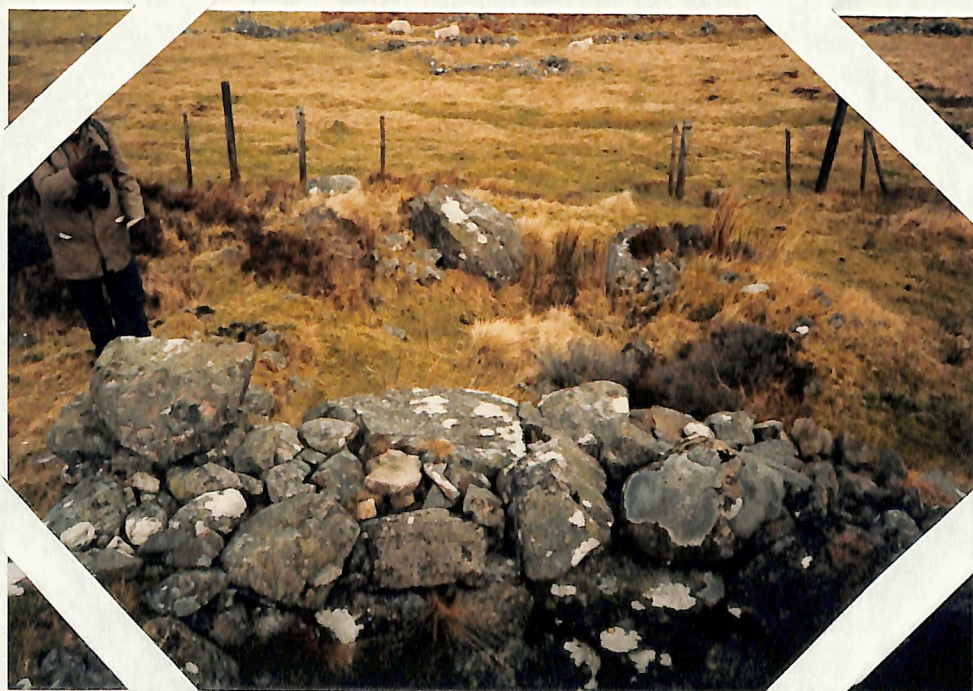
[Ref: 88/3/16-16A.]

View from the top (south end) of the kiln, attempting to embrace the whole site. The anterior lip of the kiln, much ravaged, occupies the foreground, while MA J.K. Bell, President of the Dornoch Heritage Society stands on the remains of the left-hand wall—his angle of inclination being the result of camera parallax!
